**UNITED STATES DISTRICT COURT
FOR THE NORTHERN DISTRICT OF TEXAS
FORT WORTH DIVISION**

**HENRY LEE SIMS, JR., et al.,*****Plaintiffs,*****VS.****CASE NO. 4:14-cv-00045-A****KIA MOTORS AMERICA, INC. and
KIA MOTORS CORPORATION,*****Defendants.***§
§
§
§
§
§
§
§
§
§

**APPENDIX IN SUPPORT OF PLAINTIFFS' RESPONSE IN OPPOSITION
TO DEFENDANTS' MOTION TO EXCLUDE
TESTIMONY OF PLAINTIFFS' EXPERT JERRY WALLINGFORD**

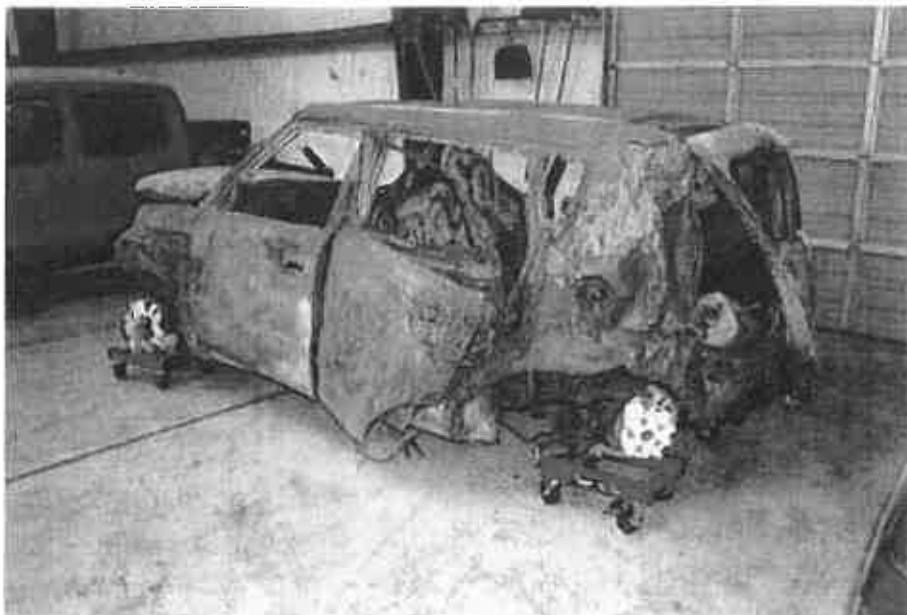
Figure 1. Verifact Corporation photograph 001 2010 Kia 1-15.
2010 Kia Soul viewed from the left rear at January 15, 2015, inspection.

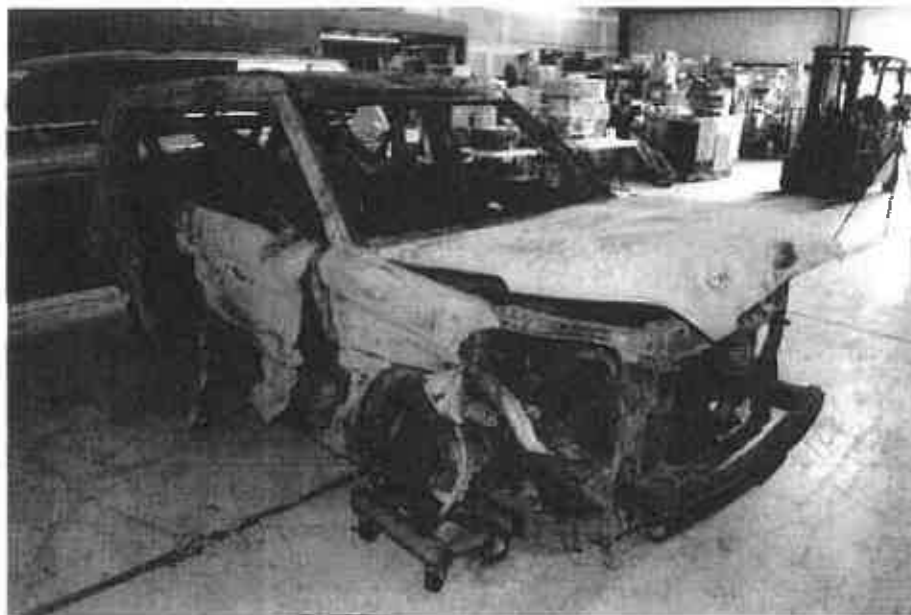
Figure 2. Verifact Corporation photograph 006 2010 Kia 1-15.
2010 Kia Soul viewed from the right front at January 15, 2015, inspection.

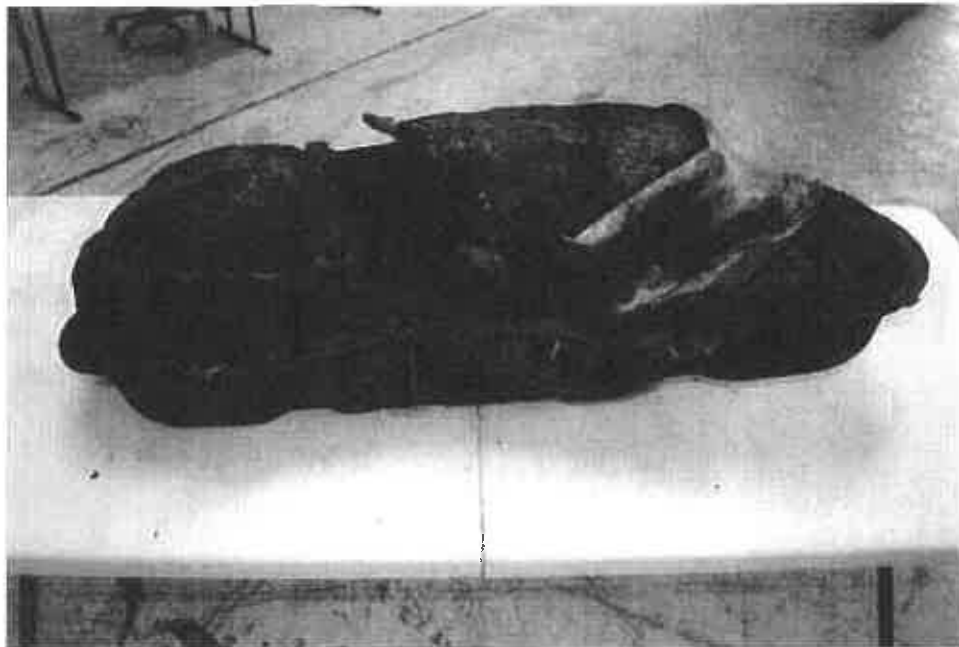
The damaged fuel tank was found stored inside the vehicle. The tank exhibited a rip/tear on the underside near the center of the tank located diagonally from the front right to the left rear. The rip/tear was measured at approximately eight and one quarter (8 ¼) inches wide near the rear of the tank. The general configuration of the rip/tear in the bottom of the tank is an inverted "T". The underside of the fuel tank is shown in Figure 3. A detailed view of the rip/tear in the fuel tank is shown in Figures 4 and 5.

Figure 3. Verifact Corporation photograph 056 2010 Kia 1-15.
Subject Kia fuel tank underside viewed from the front.

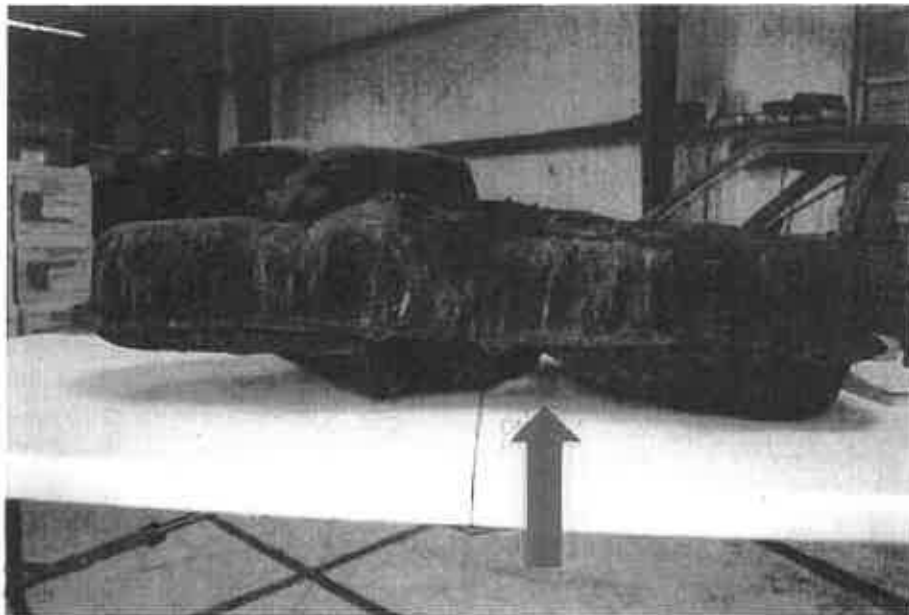
Figure 4. Verifact Corporation photograph 054 2010 Kia 1-15.
Subject Kia fuel tank front showing beginning of ripped bottom at the red arrow.

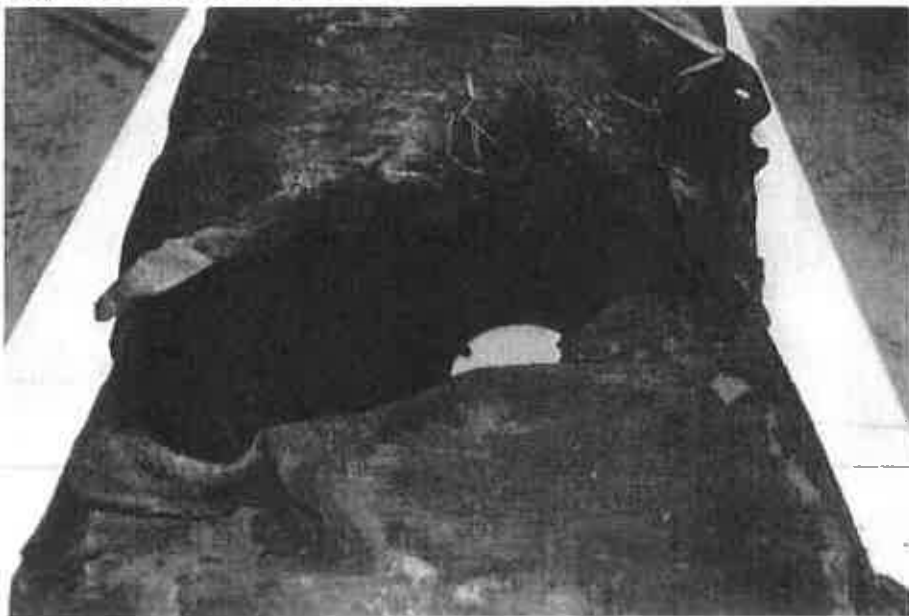
Figure 5. Verifact Corporation photograph 060 2010 Kia 1-15.
Subject Kia fuel tank underside showing the ripped bottom.

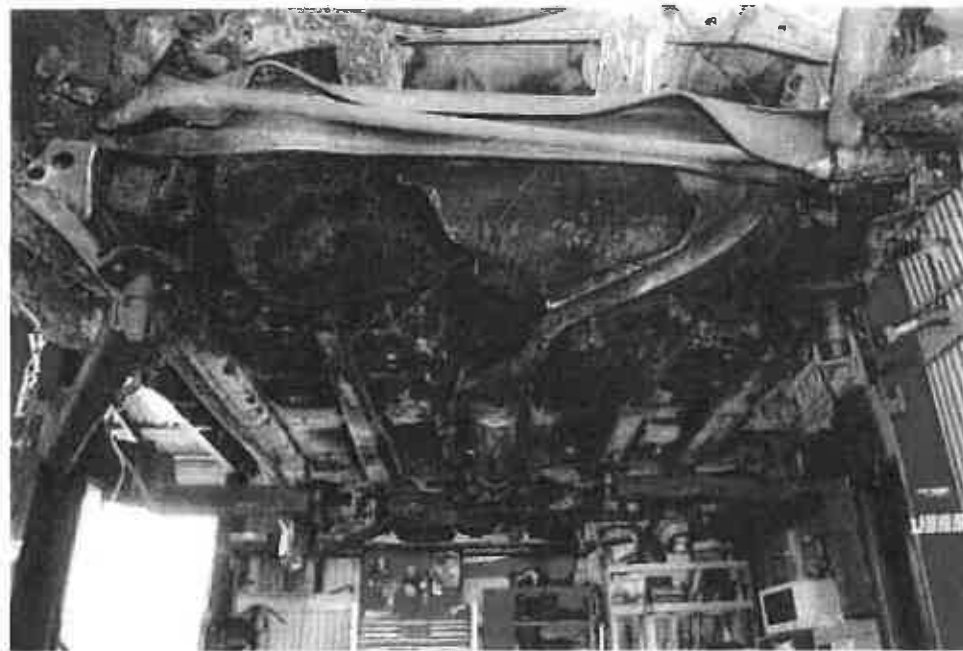
Figure 6. Verifact Corporation photograph 190 2010 Kia 1-15.

Subject Kia fuel tank installed on the subject vehicle showing the ripped bottom.

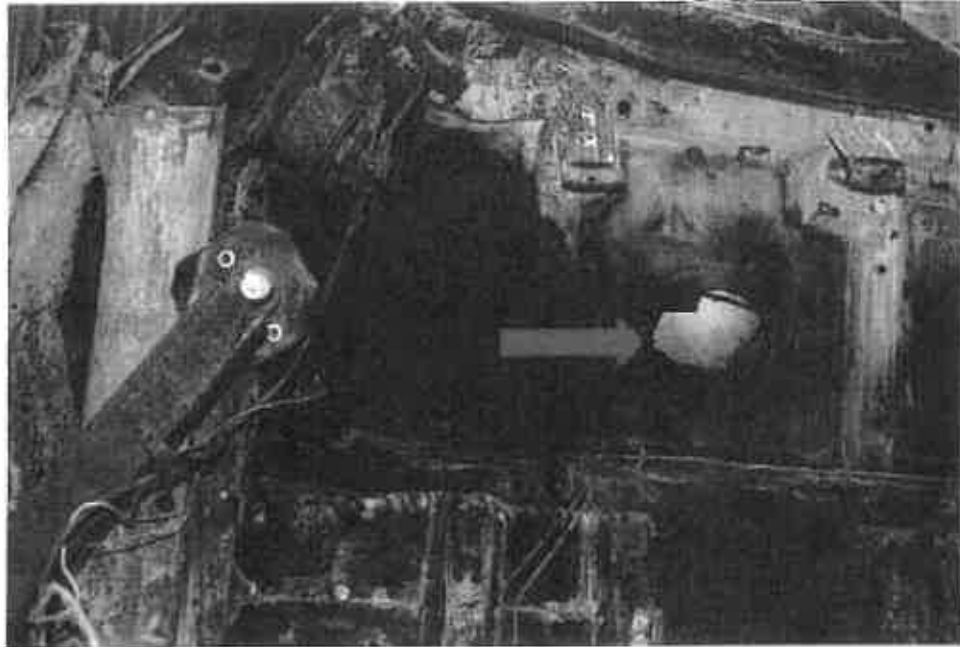
Figure 7. Verifact Corporation photograph 132 2010 Kia 1-15.

It was noted that the polymer service cover above the fuel tank mounted in the vehicle floorpan was completely missing and consumed by the fire. The polymer service cover located under the rear seat of the subject 2010 Kia Soul allowed fire to enter the occupant compartment within a short period of time. The opening where the service cover was located is shown in Figure 7 at the red arrow.

Subject Kia underside showing the service cover opening above the fuel tank mounting area.

Here, the Kia defendants elected to utilize a piece of combustible polymer for access to the fuel tank fuel pump module and to act as the barrier between the vehicle's fuel tank and the inside of the car. The polymer is not designed to be fire resistant. That decision was extremely dangerous, resulting in another defect to the 2010 Kia Soul.

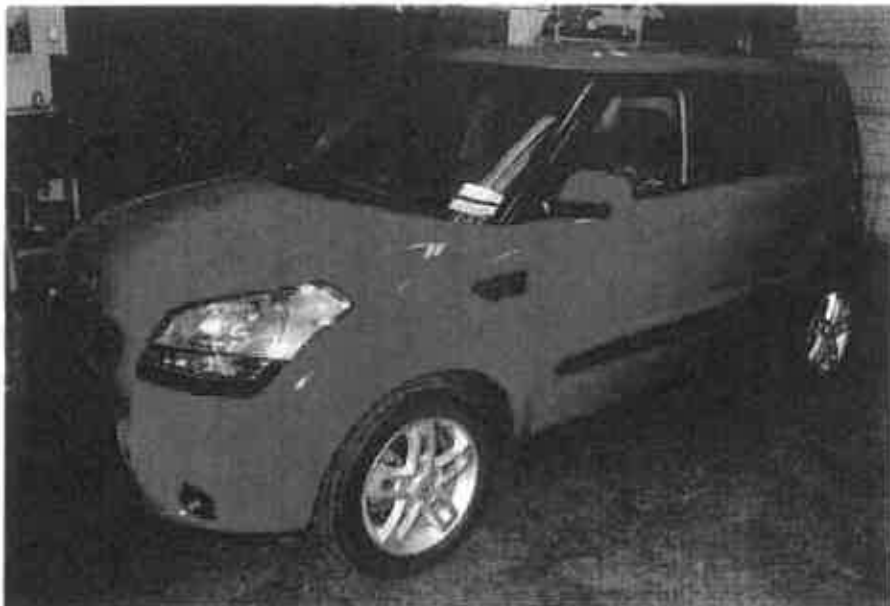
Figure 8. Verifact Corporation photograph 03 14-112-FP EX.
Exemplar 2010 Kia Soul at the time of inspection.

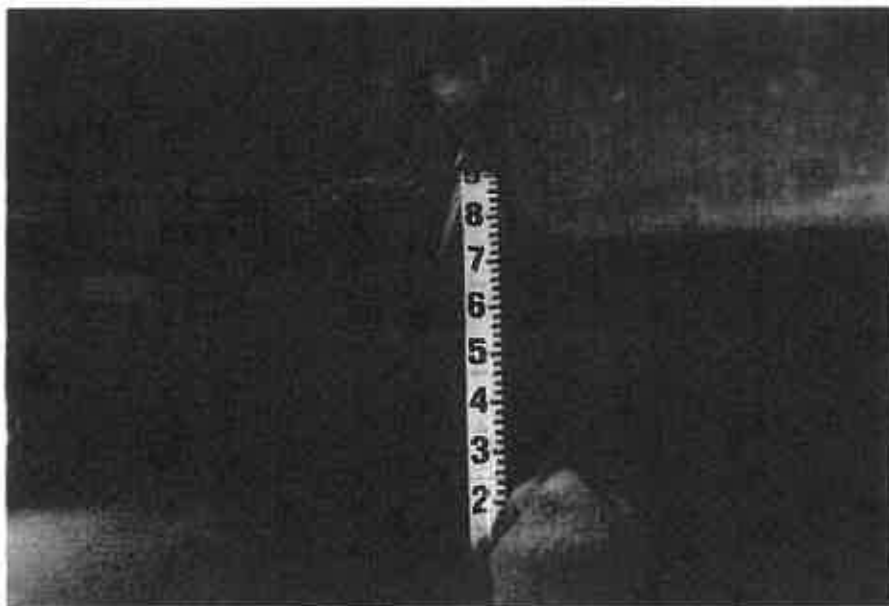
Figure 9. Verifact Corporation photograph 25 14-112-FP EX.
Exemplar 2010 Kia Soul fuel tank ground clearance.

The Kia Soul's fuel tank has a ground clearance of approximately 210 millimeters (slightly more than 8 inches). This would provide approximately 4.5 inches in ground clearance between the fuel tank of the vehicle and the base of the sign under normal ride height conditions. The vehicle's movements following the collision likely lessened the ground clearance between the fuel tank and the base of the sign. However, there are feasible, commonly-utilized design alternatives that would prevented the fuel tank from directly contacting base of this obstruction and, if the break-away base could not be avoided, would have allowed the energy of the impact to be redirected or absorbed by structures other than the fuel tank.

It is my opinion that the 2010 Kia Soul failed to maximize the ground clearance provided for its fuel tank. This is extremely dangerous considering that vehicle's tank is not protected by any of the accepted methods used by automakers. If the Kia defendants had taken advantage of the additional space provided by the body of the Kia Soul to increase the ground clearance of the vehicle fuel tank, I believe that the road sign base would have been avoided altogether.

1. Kia should have taken advantage of the additional space provided by the body of the Kia Soul to increase the ground clearance of the vehicle fuel tank to avoid striking the road sign base which would have avoided the fuel tank damage and the subsequent fire altogether.

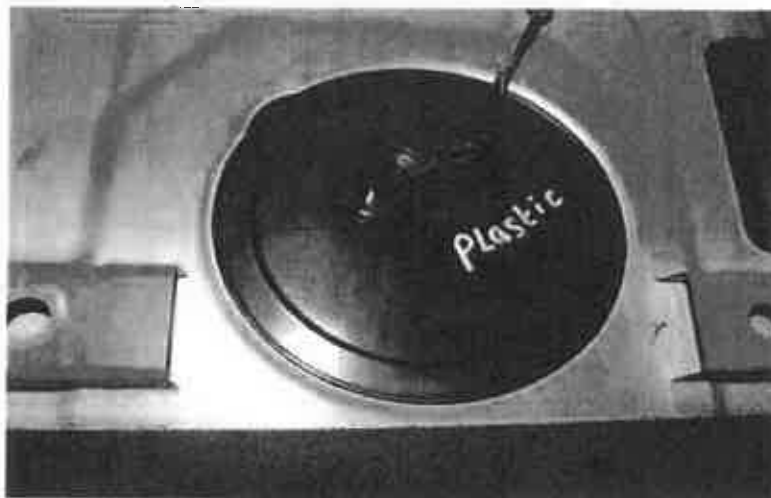
The fuel pump service cover used on the 2010 Kia Soul is made entirely of polymer. A photograph of the service cover found beneath the rear seat of an exemplar 2010 Kia Soul is shown in Figure 12.

Figure 12. 2010 Kia Soul service cover.

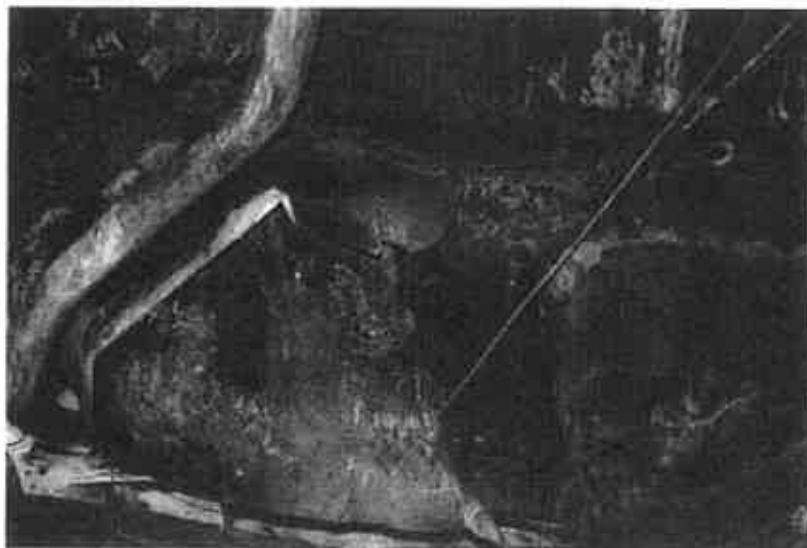
The measurements from the base of the Yield sign align nearly perfectly with the tear observed in the vehicle's tank as shown in figures 13, 14 and 15.

Figure 13. Verifact Corporation photograph 193 2010 Kia 1-15.
Tear in the fuel tank of the 2010 Kia Soul.

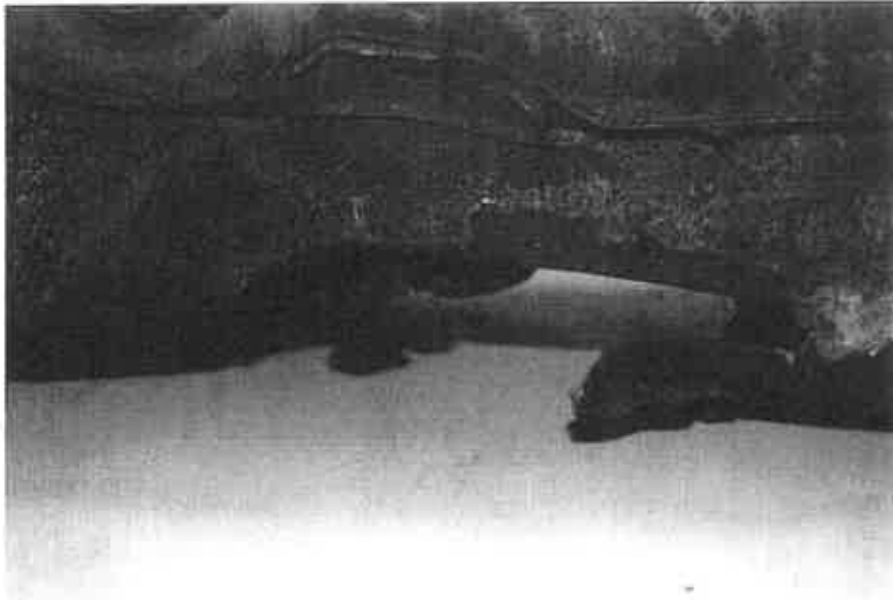
Figure 14. Verifact Corporation photograph 193 2010 Kia 1-15.
Tear in the fuel tank of the 2010 Kia Soul viewed from the rear.

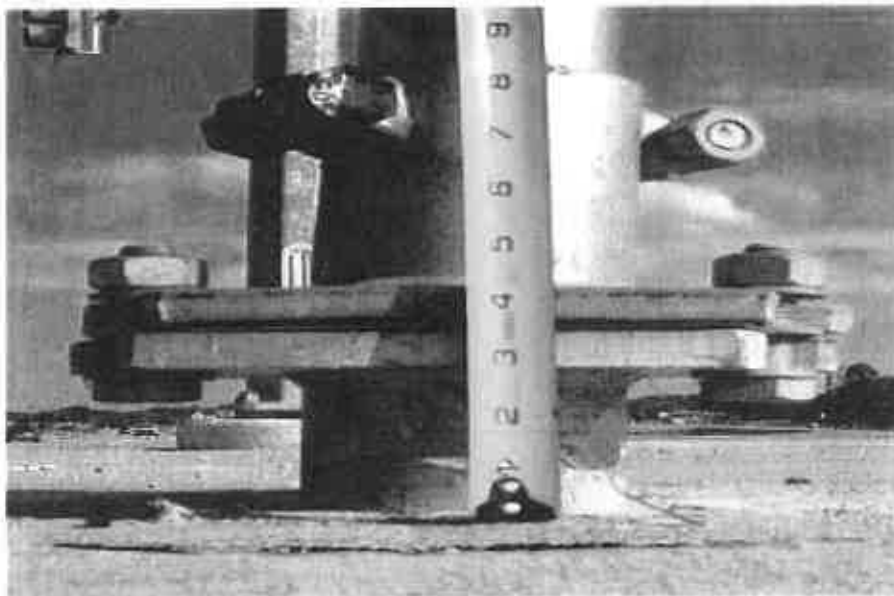
Figure 15. Yield sign base in an unidentified photograph provided by Mr. McLean.
